CASE HISTORY SPOTLIGHT

Case History 231: Restoring Chemical Manufacturer's Plant

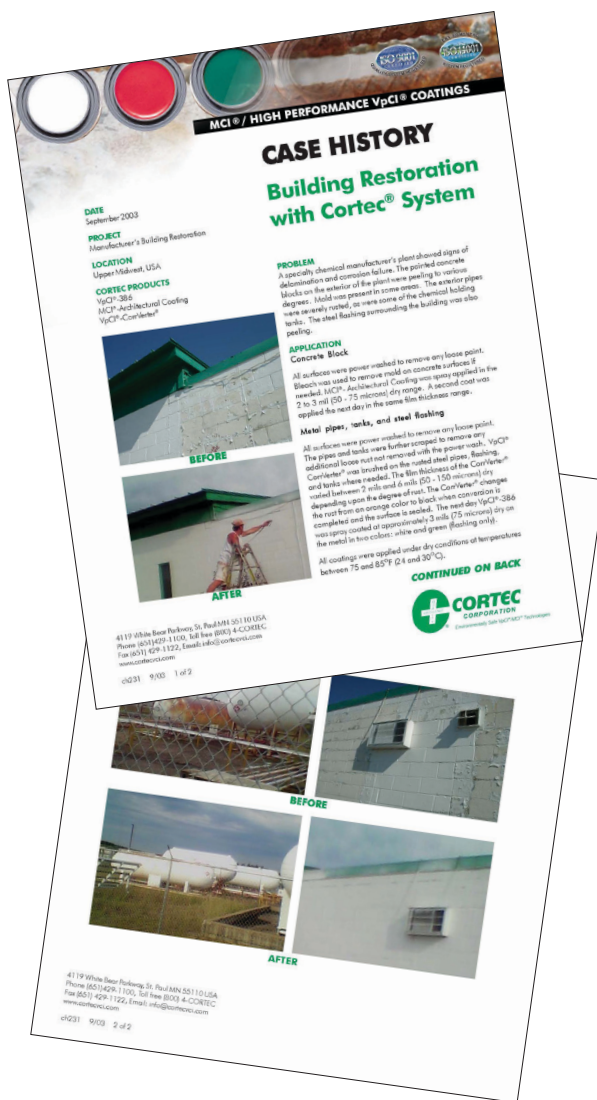
A specialty chemical manufacturer's plant was in serious need of a makeover. Paint was peeling from exterior concrete blocks and steel flashing. Some mold was present. Exterior pipes and some of the chemical tanks were also severely rusted.

After power washing loose paint and bleaching moldy areas as needed, the work crew applied two coats of MCI® Architectural Coating on the concrete surfaces. They also power washed and scraped loose paint off pipes and tanks. CorrVerte® was applied to rusty surfaces on pipes, flashing, and tanks and allowed to dry, followed by a topcoat of VpCI®-386 tinted in white or green (flashing only).
