CASE HISTORY SPOTLIGHT

Case History #335: Refurbishment of Military Displays

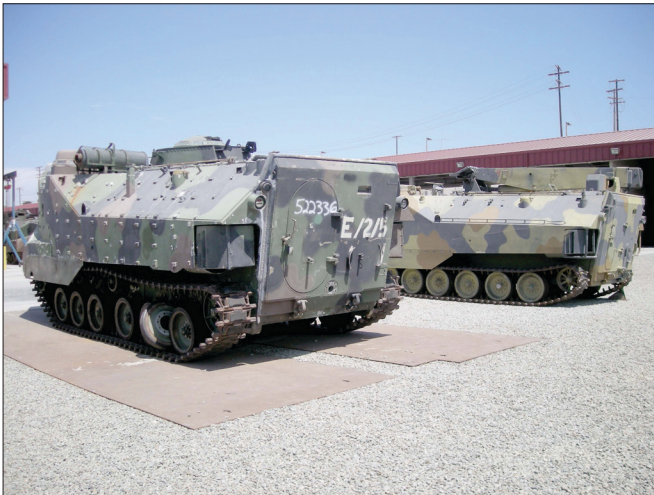
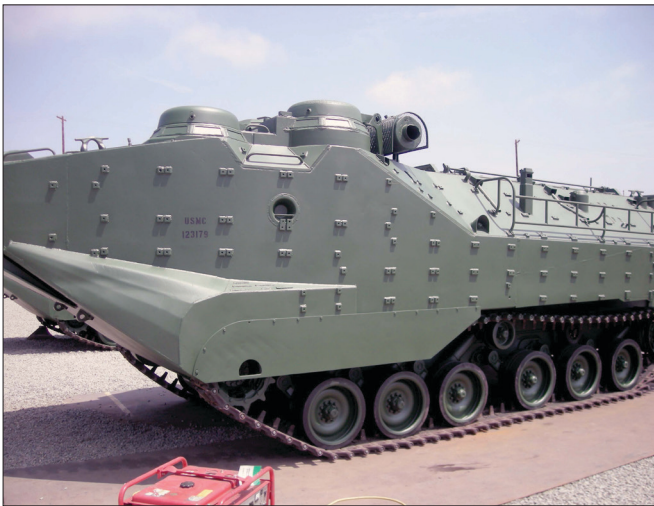
Two military AAV (amphibious assault vehicle) museum display pieces needed a new durable topcoat. One of these AAVs had been retired for about 10 years and only required a topcoat, while the other was heavily corroded and oxidized after spending three months under water off the coast of Okinawa. Surface rust was removed from rims, tie downs, and bolt heads using wire brushes and scrapers before cleaning surfaces with isopropyl alcohol and applying VpCI® CorrVerter®. Aluminum oxidation, barnacles, and loose paint were also removed from the vehicle, and rough surfaces “feathered” with sandpaper. All AAV surfaces were wiped clean once again with isopropyl alcohol before finally applying a VpCI®-375 corrosion inhibiting topcoat by a combination of brush, roller, and airless spray. The two coatings seemed well-suited to the job with little need for touchup.
