CASE HISTORY SPOTLIGHT

Case History #405: Restoration of Rusty Tennis Court Infrastructure

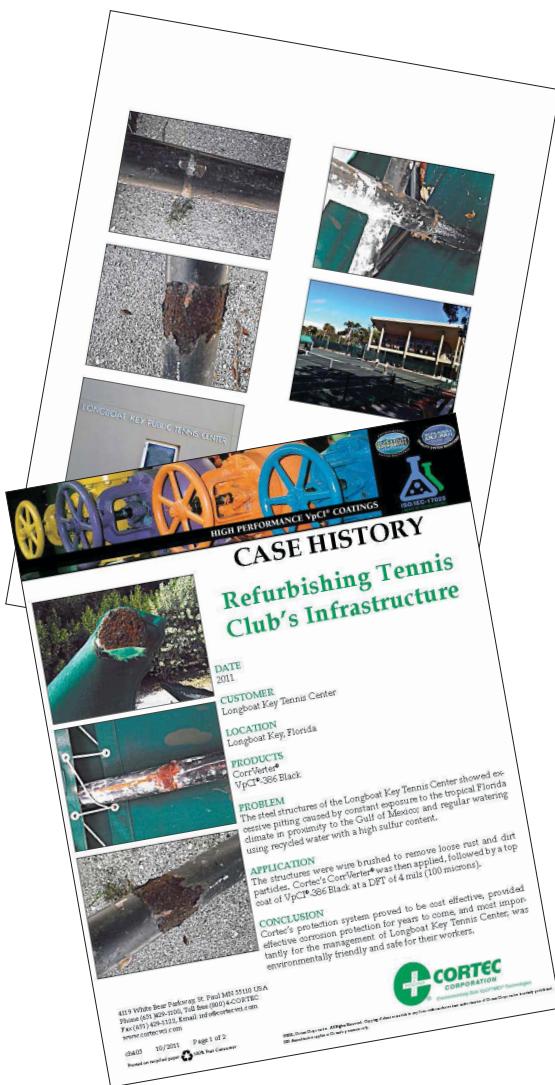
Even tennis courts sometimes stand to benefit from a little restorative work with Cortec® coatings. This was the case at the Longboat Key Public Tennis Center, located on the small Gulf Coast island vacation hotspot of Longboat Key, Florida. Steel structures on the tennis courts were suffering from corrosion due to the aggressive subtropical Gulf Coast climate, in addition to the corrosive attack from regular watering using water with high sulfur content.

After removing loose rust and dirt with a wire brush, workers applied CorrVerter® Rust Converter Primer to the rusty metal structures, followed by a 4 mil (100 micron) DFT topcoat of VpCI®-386 Black. This served as a cost-effective corrosion protection method for the tennis center with the added benefit of having a low environmental impact.
