Case History Spotlight #445: Reclaiming Rusted Gas Tubes

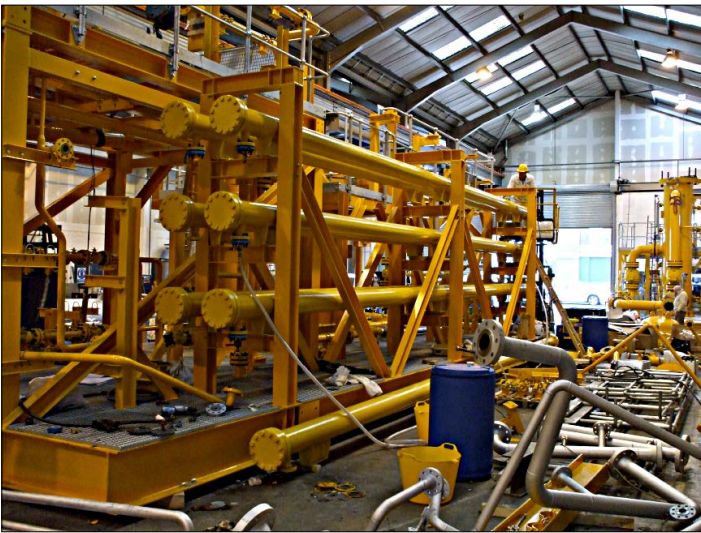
A client needed to reclaim seven gas tubes that had corroded by the end of their transport from the US to the UK. Workers proceeded to soak the tubes in [VpCI®-422](#), followed by a solution of [VpCI®-416](#) for cleaning/degreasing. They then removed debris and inspected and measured the tubes. Two of the seven were so severely corroded that they required re-honing before preservation. The other five were treated internally with a solution of [VpCI®-377](#) for continued rust prevention until installation and use. The ability to restore five of the seven tubes saved the client millions of US dollars, turning the project into a significant cost-saving measure.
