CASE HISTORY SPOTLIGHT

Case History 597: Cortec® Restores CorteCros® Warehouse Using MCI® Products

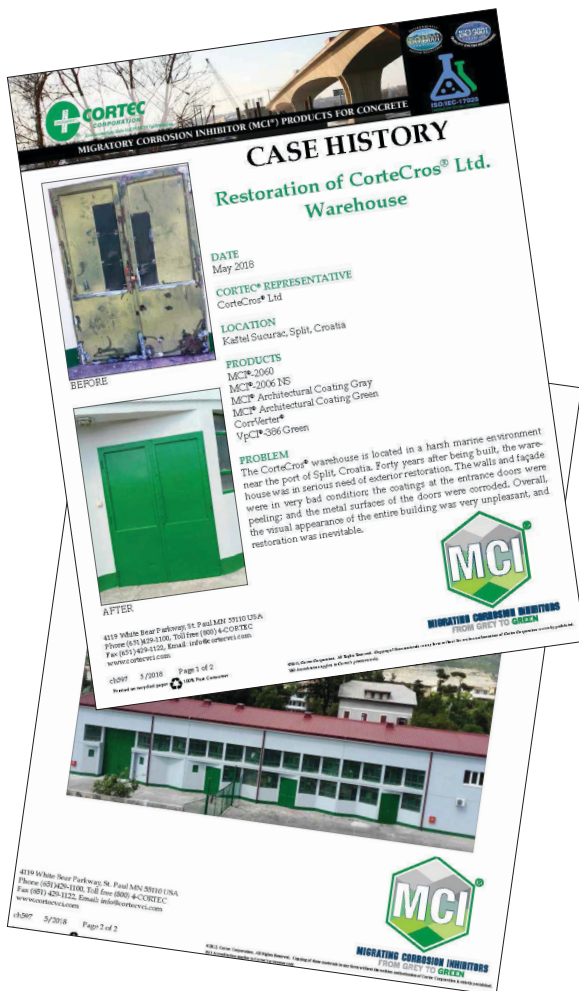
After 40 years in a harsh marine environment, Cortec's CorteCros® warehouse in Split, Croatia, was in serious need of exterior restoration.

The dirty walls and peeling paint were cleaned off by pressure washing with MCI®-2060 Concrete Cleaner/Degreaser. MCI®-2006 NS was used in repair mortar for damaged surfaces on the walls. MCI® Architectural Coating Gray was applied to the building wall façade, while MCI® Architectural Coating Green was used on the jamb and plinth. CorrVerter® was applied to corroded parts of the metal doors and covered with a topcoat of VpCI®-386 Green.

CorteCros® expects to get 15-20 more years of service life out of the building after the restoration.
