# Intriguing Cortec® White Paper Details

## Saturn V Rocket Engine Conservation

# Saturn V Rocket Engine Conservation

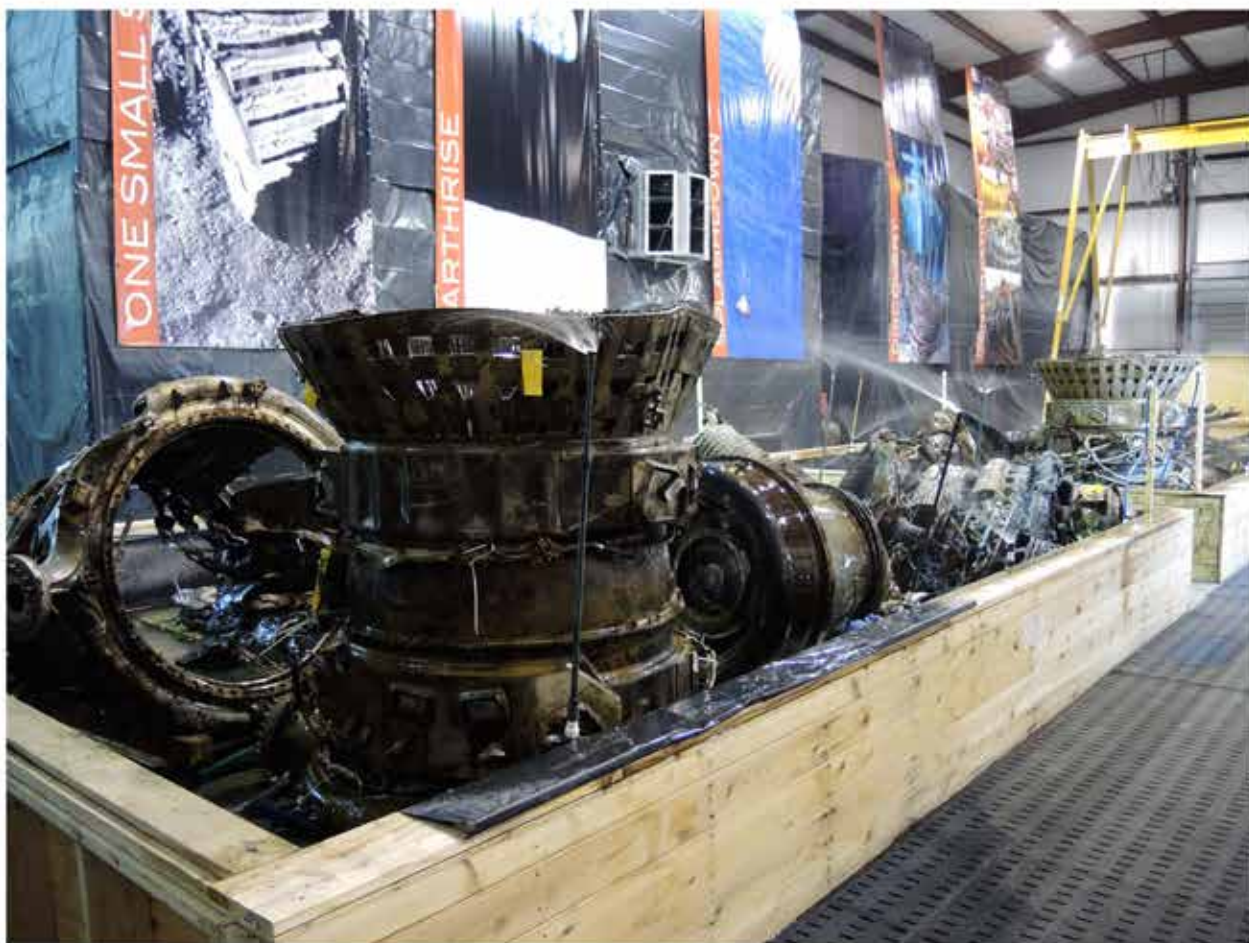
Figure 1: View of the lab with recently recovered artifacts in treatment. Photo credit: Terra Mare Conservation, LLC

The pieces were collected from the floor of the Atlantic Ocean after exposure to over 40 years of incredibly corrosive, saline water. To aid the chloride removal process, Cortec's FlashCorr® VpCl® was incorporated into a showering system used to keep the artifacts wet until they could be immersed in large basins filled with the same FlashCorr® VpCl® solution. This immersion process removed the majority of the free chloride ions and rust staining, greatly reducing the time required for this phase of the conservation. Once conservators finished removing the remainder of the sediment and other deposits, some of the parts required further corrosion protection. In order to preserve these parts for storage, a dilute solution of VpCl®-377 was applied to their surface. This allowed the surface appearance and texture to remain unchanged while still offering corrosion protection.

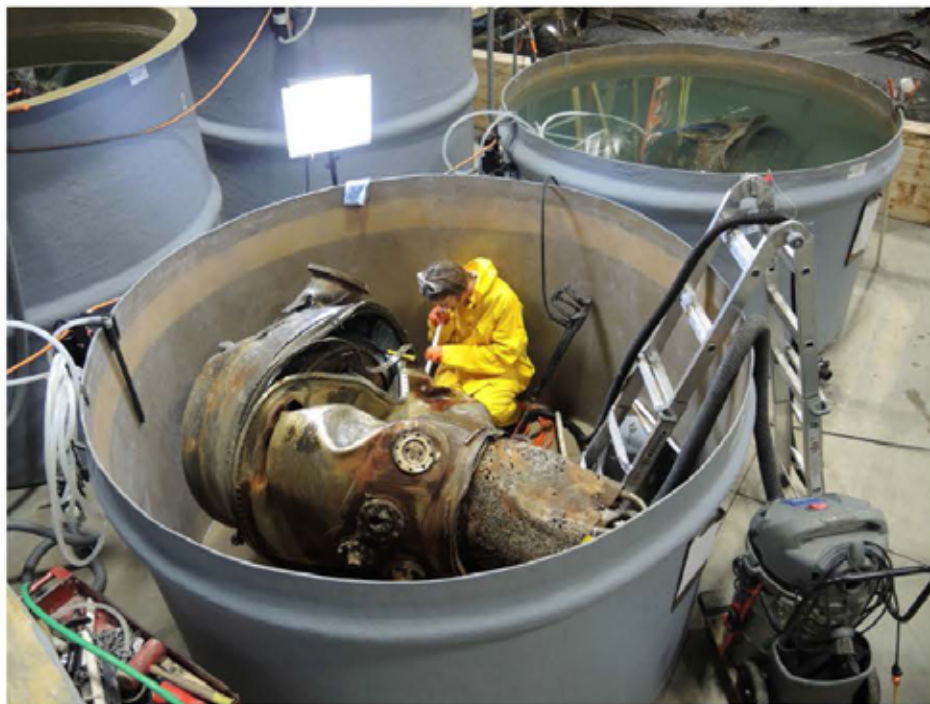
Figure 2: A conservator works in a treatment tank to remove loosely adhered residue between soakings in dilute FlashCorr<sup>®</sup> solution (pictured in background).

Chemically stabilizing the components by removing chlorides and rust stains took place in separate basins filled with a 0.1% solution of FlashCorr® VpCl®. Due to the large affinity FlashCorr® VpCl® has for metal, it can preferentially displace chlorides from metal allowing for their capture in an aqueous solution. This system allowed the conservators to easily remove the most severe rust stains and extract the majority of the chlorides from the metal surface by periodically refreshing the solution and manually washing the metal surface.

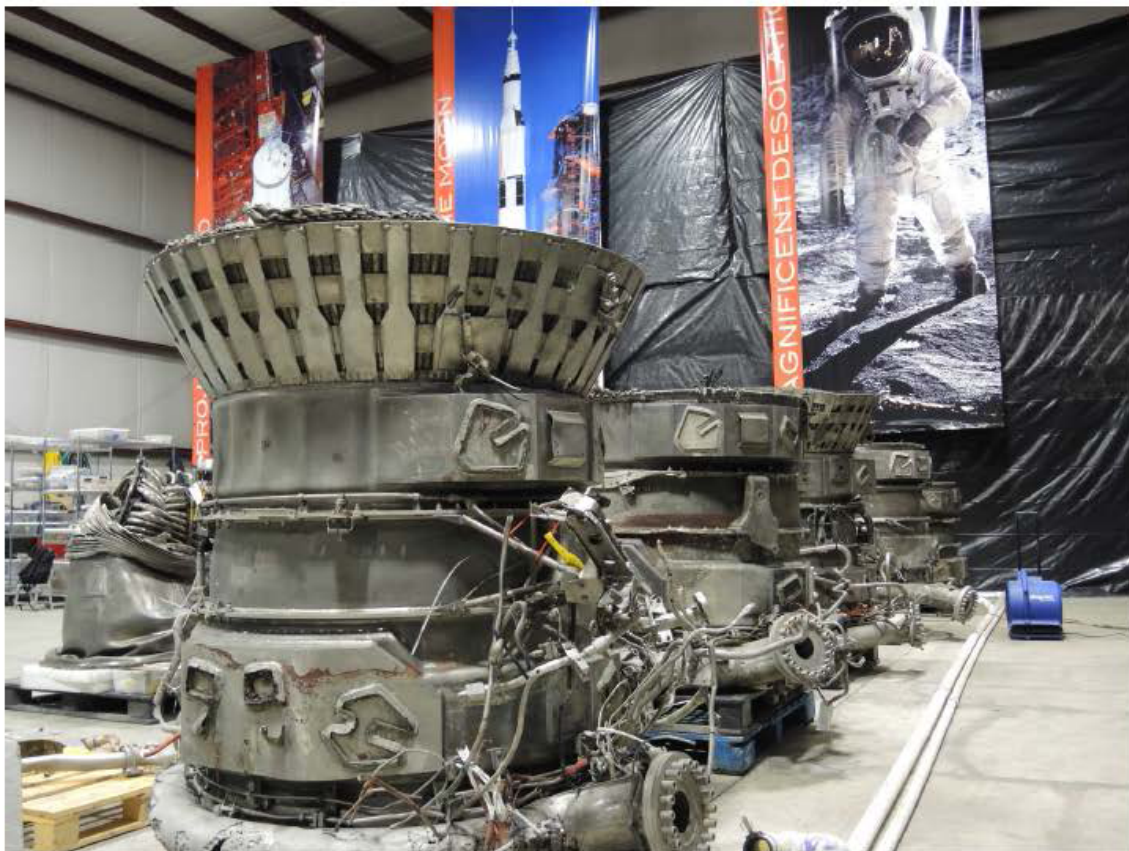
Figure 3: The final cleaned and reassembled engine parts awaiting shipment for museum display and storage. Photo credit: Terra Mare Conservation, LLC

Once the metal surfaces were completely cleaned and stabilized by the many methods employed by the conservators, a 2.5% solution of VpCI<sup>®</sup>-377 was used on selected objects to ensure that the artifacts did not suffer further corrosion while at the same time not affecting the appearance of the artifact. VpCI<sup>®</sup>-377 protects ferrous and yellow metals as well as aluminum, so it offers a one-size-fits-all solution to thin-film protection, and due to its wide dilution range, it is not difficult to adapt a solution to specific visual or protection requirements.
