**PRESS RELEASE**

## VpCI® Packaging to the Rescue for Insidious Condensation Corrosion

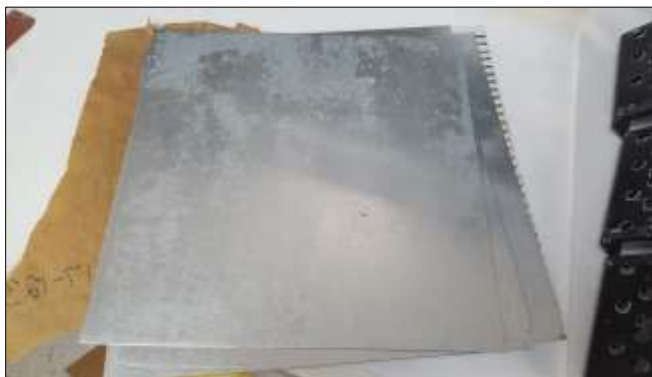
No protection

To simulate the warm-cold cycles and find a protective solution, Cortec® Laboratories stacked galvanized sheet metal with VpCI®-146 paper layered in between the individual steel panels. The lab moved the panels back and forth between a freezer (at approximately -31°F [-35°C]) and a warmer non-temperature-controlled environment to promote condensation cycles daily. By the end of the two-week trial, white rust had formed on the top and bottom panels, where there had been no protective paper. However, surfaces between the plates (where the VpCI®-146 showed signs of alternate water saturation and drying from condensation) had been protected.

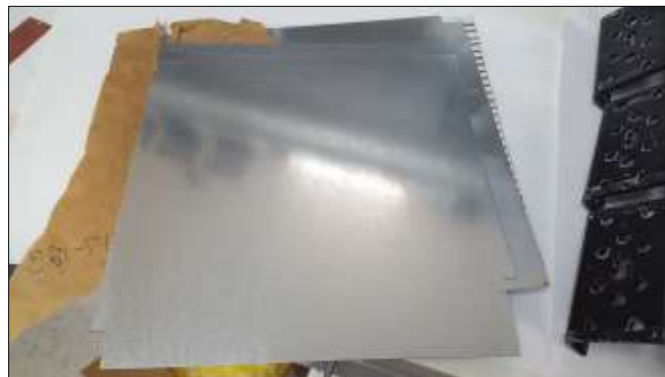
Protected with VpCI®-146 paper
