**Attention: Editor  
November 14, 2023  
PRESS RELEASE**

## **Fighting the Danger of Overprotection on Concrete Repairs**

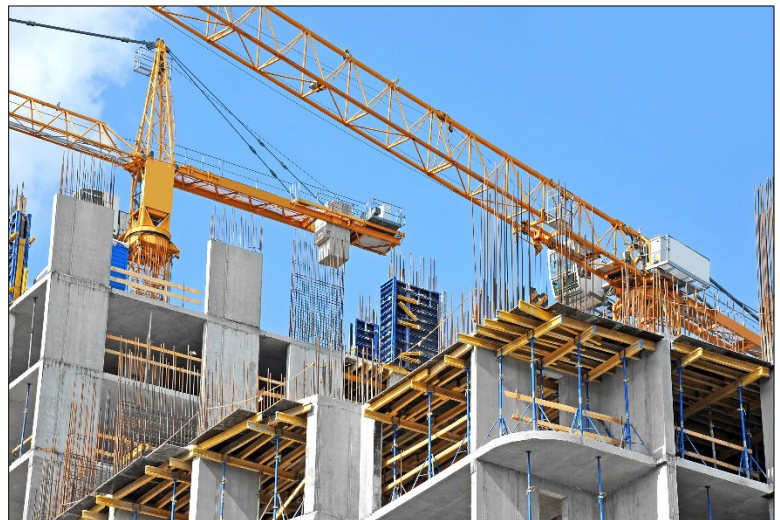
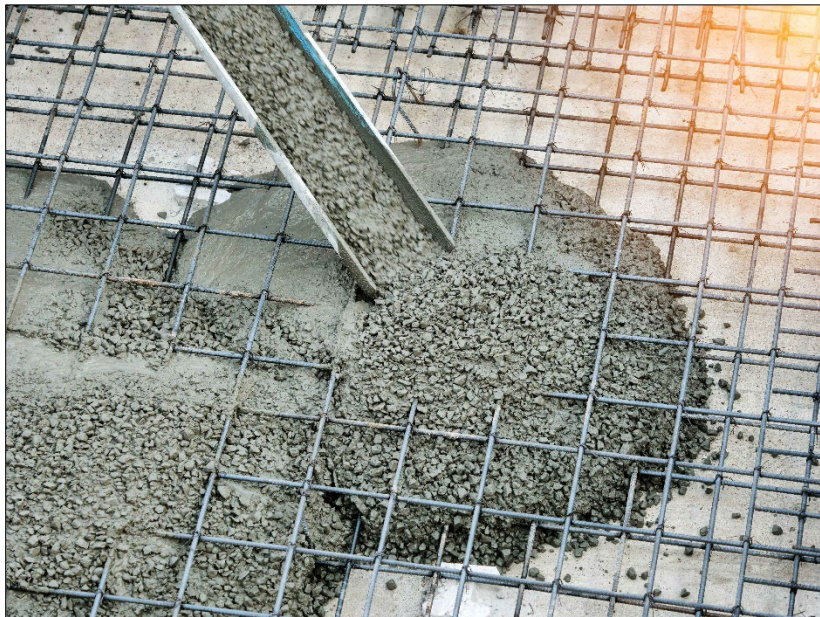
Overprotection occurs when metal reinforcement in one part of the concrete is more protected than in another. This can happen when a new concrete patch is laid, replacing contaminated or carbonated concrete with uncontaminated concrete that has a high pH and therefore a naturally protective alkaline environment. The resulting difference in corrosion potential between the patch and the adjacent concrete eventually leads to corrosion in surrounding areas, thus transferring the original problem elsewhere. This is known as the ring anode / halo effect.

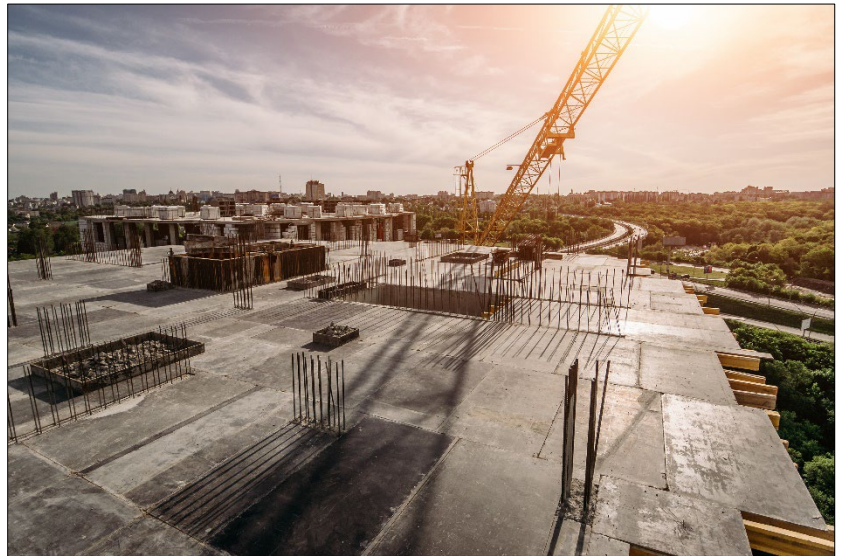
The use of MCI<sup>®</sup> Surface Applied Corrosion Inhibitors (SACIs) makes it easier to balance out the corrosion potential. Rather than leaving a well-protected patch surrounded by chloride-contaminated concrete, contractors can apply MCI<sup>®</sup> SACIs to the undisturbed concrete in an effort to reduce the difference in corrosion potential between two portions. Fortunately, MCI<sup>®</sup> SACIs are easy to apply by spraying onto the concrete like a standard

surface treatment. As time progresses, Migrating Corrosion Inhibitors in the MCI<sup>®</sup> SACI work their way deeper in through the concrete pores toward the metal reinforcement. Their affinity to metal allows them to form a protective molecular layer on the embedded rebar when they encounter it.
