RUST BOMB

CORTEC VPCI-423

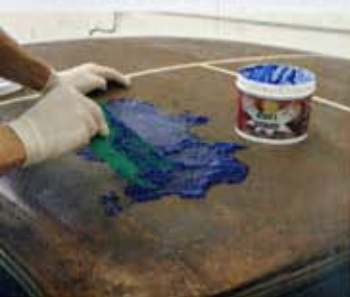
> The bright blue goo worked effectively and quickly. After two applications that were allowed to sit overnight, our rusty roof was stripped down to bare steel nearly everywhere. One more application in the heavy spots and we'd be rust-free.

Verdict: Works exceptionally well and very quickly. The only downside is it took a whole quart to finish a quarter of our roof.
