# Cortec's solutions rehabilitate vulnerable structures

*MCI® technology used to restore historical buildings in Europe!*

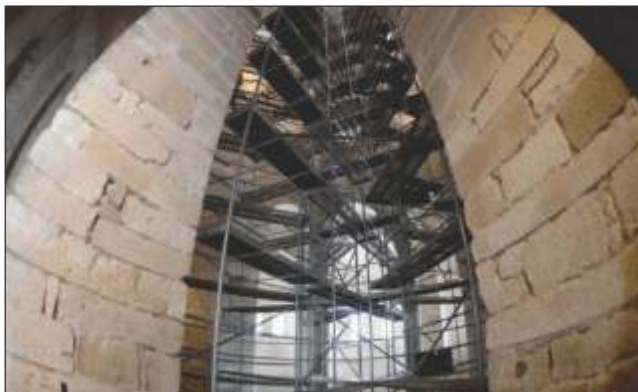
*The moisture penetrating into the medieval monument, in combination with the sea dust, very seriously endangers the reinforced-concrete structure, which holds the church of St. Donat.*

Last year a repair project was initiated and Cortec's MCI® 2020 inhibitor was specified as coating to protect support structure against corrosion. MCI® 2020 is a surface applied corrosion inhibitor designed to migrate through even the densest concrete structures and seek out the steel reinforcement bars in concrete. Even when not in

direct contact with metal, the product will migrate through concrete to provide full protection. This environmentally safe inhibitor stops further corrosion of reinforcing metals, significantly extending the service life of the structure.

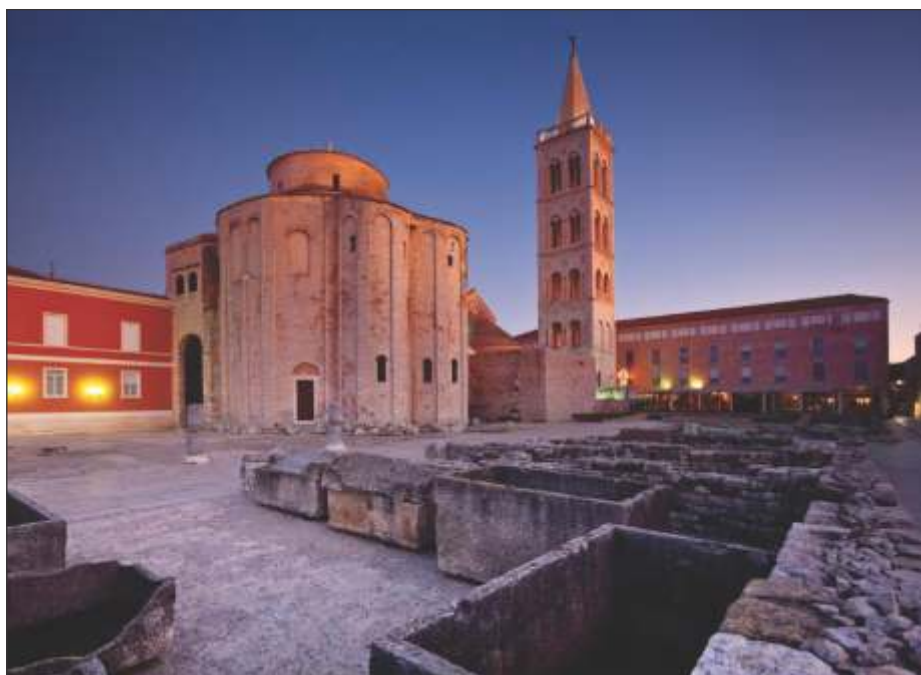
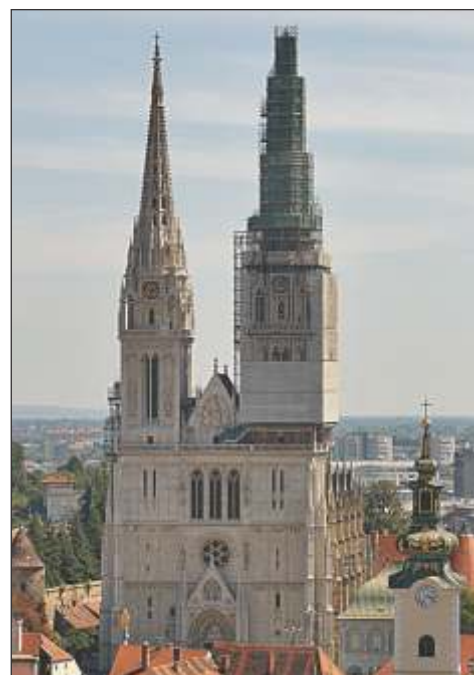
*Saint Donatus church (left) and Zagreb Cathedral (right) are among o most valuable European historic monuments. Architects and engineers recognized Cortec's world renowned MCI® technology for restoration of these delicate, vulnerable structures.*

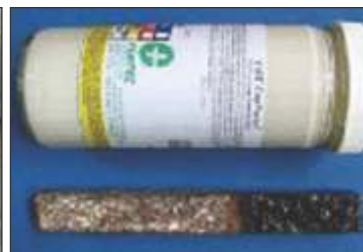
Left picture: Damaged steel bands. Right picture: CorrVerter® applied to the right side of the band; the coating has converted the corrosion into a protective layer.

During reconstruction work on the south tower, damaged steel bands were detected surrounding the tower approximately every 3m in height. They were covered with rust and in drainage areas. Visual damage to the diameter of the bands was present.

tower needed to be maintained or improved. Faculty of Mechanical Engineering examined the bands and performed experiments on the steel bars. They recommended removal of loose corrosion from the bands surfaces, enhancing the bands in the areas of damage and application of Cortec's anticorrosion protection product- CorrVerter®.

This water-based primer that quickly converts rust into a protective layer and is capable of penetrating into the depths of corroded surfaces. It contains a novel chemical chelating agent that modifies surface rust into a hydrophobic passive layer. Two-layers of CorrVerter® coating were brushed onto smaller surfaces and sprayed in larger areas directly onto the metal bands. The bands were then reinforced with steel fishplates that were welded on the bands and also protected with CorrVerter®.

With the help of a skilled team and good project management the entire project was completed successfully with minimal cost or intrusion as specified. CorrVerter® coating penetrated to the non-corroded part of the metal and stopped further advancement of the corrosion process.
