# Mitigating The Reverse Midas Touch of Fertilizer Corrosion

**Julie Holmquist and Lisa Marston,**  
**Cortec® Corp., USA,** outline how an annual  
preventative maintenance solution promises  
to slow down the corrosion clock in the  
production, distribution, and application  
phases of the fertilizer industry.

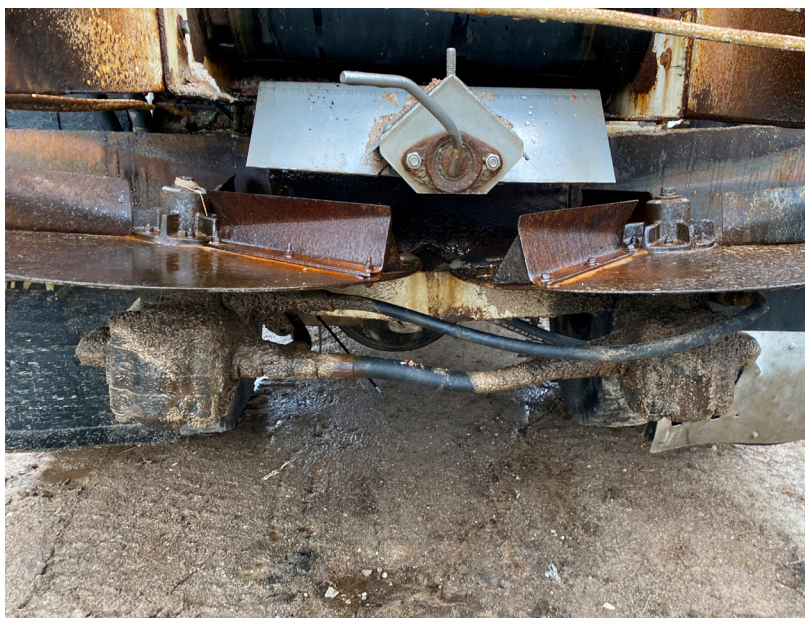
**Figure 1.** The impact of corrosion on a fertilizer spreader truck. Image courtesy of Cortec®/Anthony Price.

expensive fertilizer spreaders in good condition. Pretty much all parts of the equipment that the fertilizer touches suffer from this problem. From the pans to the bed to the braces and hose fittings, these spreader trucks are in such bad condition that they either need to be replaced or rebuilt every few years.<sup>1</sup> This problem is by no means isolated, as small and large firms at different stages of the fertilizer industry struggle to preserve asset integrity. Fortunately, one simple annual preventative maintenance solution promises to slow down the corrosion clock in the production, distribution, and application phases of the fertilizer industry.
