Attention: Editor
January 19, 2023
PRESS RELEASE

Preservation of Croatian Historical Structures with MCI® Technology!

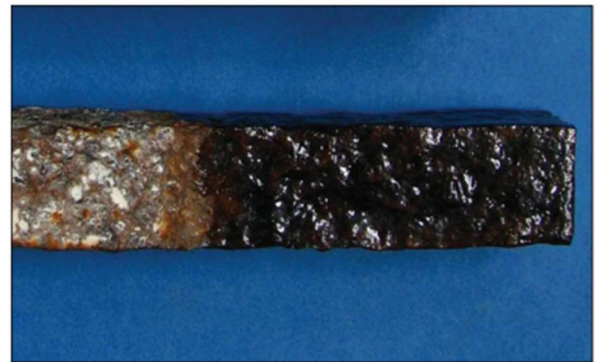
CorrVerter® MCI® Rust Primer is applied to the right side of the joint; the coating has converted the corrosion into a protective layer.

It was suggested that a minimal range of intrusion be used to keep the mechanical resistance and stability of the tower structure at their existing level while keeping costs at a minimum. Cortec's CorrVerter® MCI® Rust Primer was recommended for corrosion protection. CorrVerter® is a water-based product that quickly converts rust into a protective layer and is capable of penetrating into corroded surfaces. It contains a novel chemical chelating agent that modifies surface rust into a hydrophobic passive layer. A metal brush was used to remove loose rust from the joints. Then, two layers of CorrVerter® MCI® Rust Primer coating

were applied directly onto the metal. A brush was used for CorrVerter® MCI® application on smaller metal joint surfaces, while spray application was used for larger areas. The first coat was applied at a thickness of 100 microns (4 mils). A second coat was applied at a thickness of 75 microns (3 mils). During application, the coating temperature was 13 °C (55 °F). The joints were then reinforced with steel fishplates that were welded onto the joints and also protected with CorrVerter® MCI® Rust Primer. The final step was to replace the stones around the joints. With the help of a skilled team and good project management, the entire project was completed successfully with minimal cost and intrusion as specified. The coating penetrated into the metal and stopped further advancement of the corrosion process.

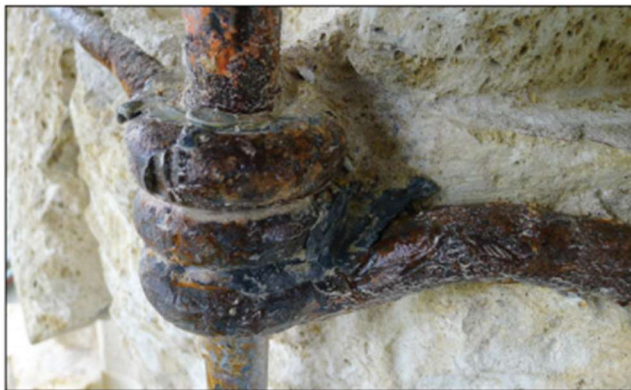
Damaged Joint

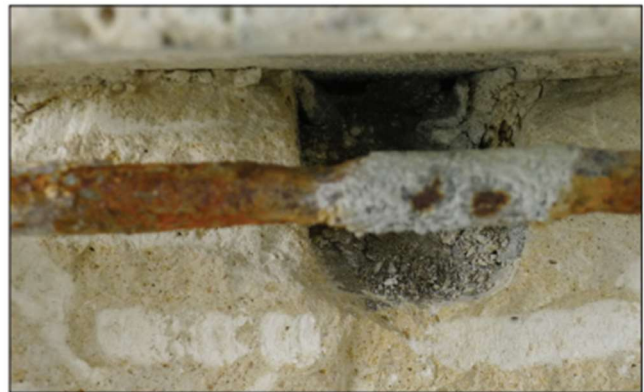
Damaged Joint

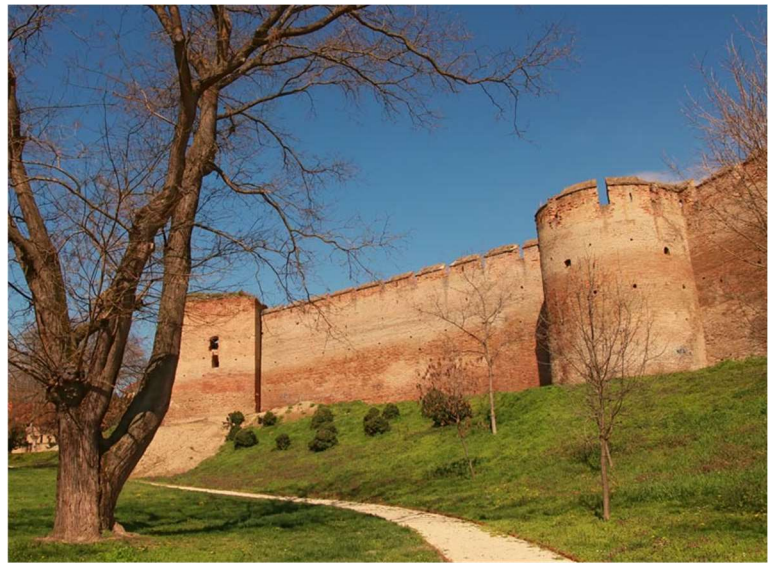
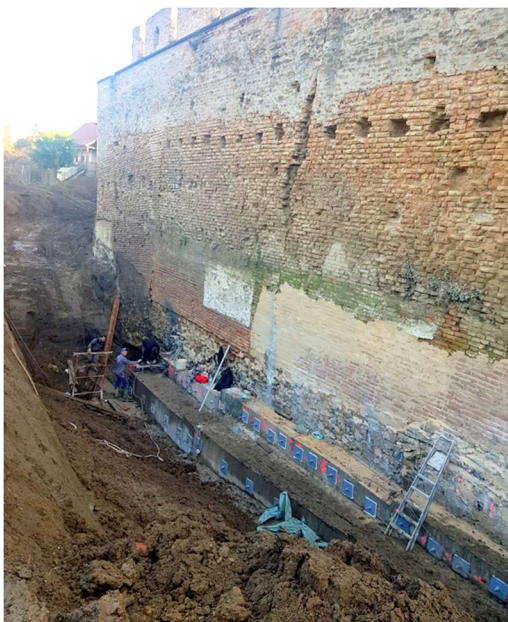
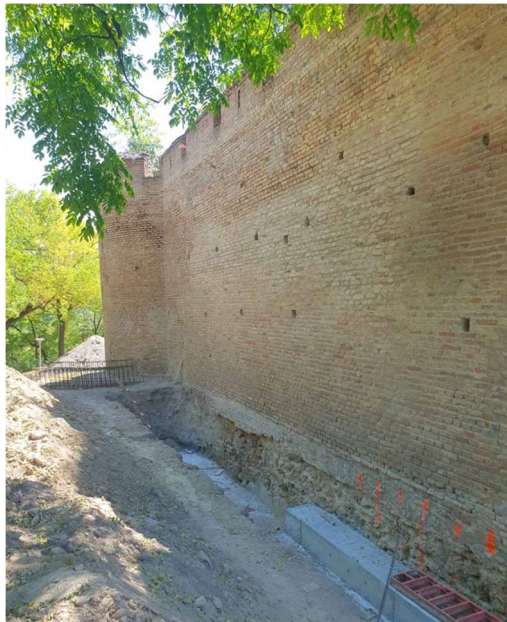
Reinforcement of the foundation of medieval city walls with MCI® Technology.

Cortec's corrosion inhibitor, MCI®-2005 is added into concrete being used to reinforce the foundation. This amine-carboxylate based corrosion inhibitor additive will be used to protect embedded metallic reinforcement from corrosion in order to extend the lifetime of the walls. MCI®-2005 is a water-based, organic

corrosion inhibiting admixture with set-retarding effects. When incorporated into concrete, it migrates towards reinforcement to form a molecular layer that inhibits the corrosion reaction on both anodic and cathodic
