Facing the maintenance of renewable assets

Sustaining wind farms with VpCI® technology!

Due to an extremely corrosive environment, a wind farm in Brazil was having significant corrosion issues which were successfully overcome by applying VpCI® technology.

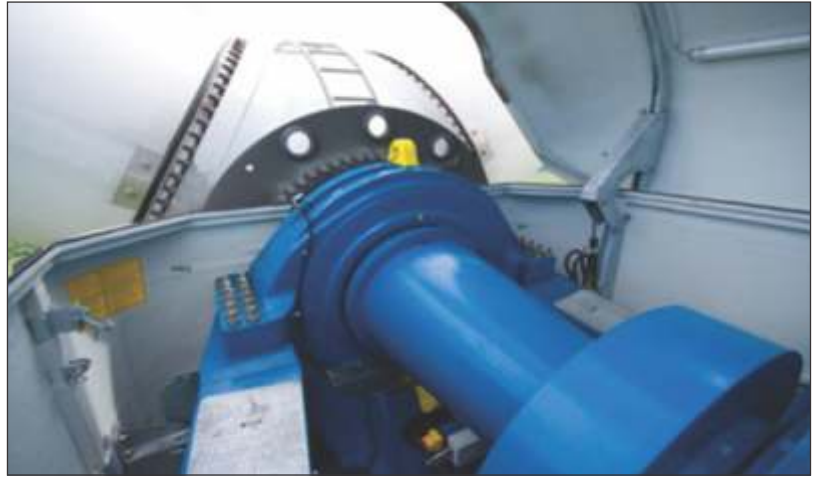
Modern wind turbines may comprise 1000 or more bolts that undergo rigid maintenance system.

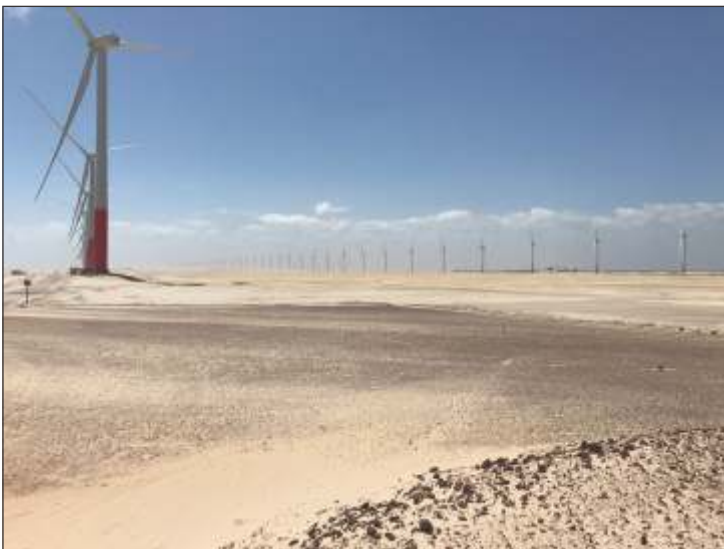
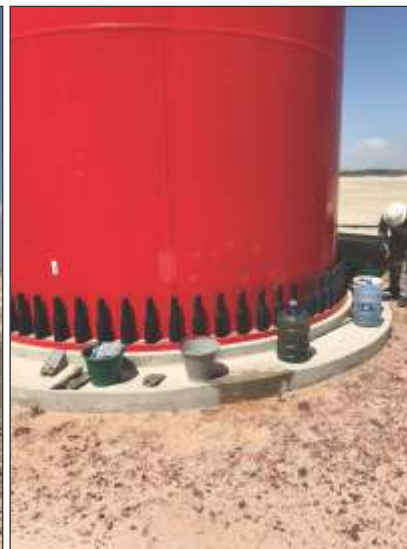
Corrosion of bolts that hold wind turbine towers to their concrete bases is a common problem at wind farms, especially those located in marine environments. This was the case at a new wind

farm in Brazil, where the base bolts were corroding due to constant exposure to the extremely corrosive environment of strong wind and blowing sand near the ocean. Clamps inside individual transformer boxes next to the tower bases were also experiencing corrosion. To protect against future corrosion, the base bolts were cleaned with Cortec's VpCI®-418 and coated with VpCI®-

Due to an extremely corrosive environment, a wind farm in Brazil was having significant corrosion issues which were successfully overcome by applying VpCI® technology.

368 prior to capping them off with a rubber gasket. Any severe rust on the base bolts or base flange faces was passivated with CorrVerter® Rust Converter Primer. The flange faces will also be top-coated with VpCI®-396 and VpCI®-384 as the customer works through its corrosion maintenance plan one wind tower at a time. The corroded clamps inside the transformer box were unbolted and cleaned with

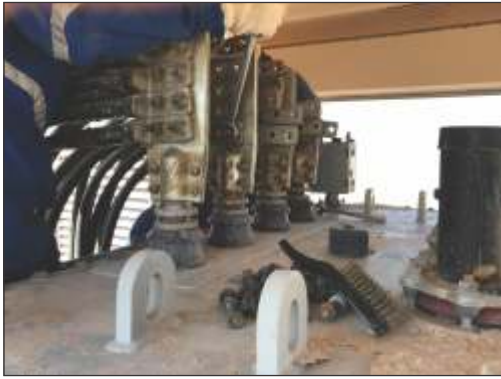
Corroded clamps in the transformer box were washed with VpCI®-415 and dried. ElectriCorr® VpCI®-239 was applied and they were bolted back into place. VpCI®-386 was used on the clamp external surfaces.

VpCI®-415 and dried. ElectriCorr® VpCI®-239 was applied before they were bolted back into place. VpCI®-386 was used to protect clamp external surfaces.

The same system was used inside transformer boxes across the wind farm. VpCI®-

396 and EcoShield® 386 will also provide protection to components inside transformer boxes. The use of VpCI® products in severe environments will greatly extend the

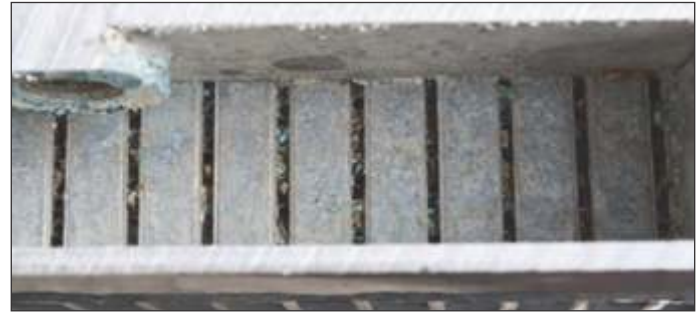
It is crucial for engineers to create a sustainable environment on wind farms by maintaining their assets in order to avoid huge financial and material losses.
